Flinders Power Facts Ash Storage Area

What is an ash storage area?

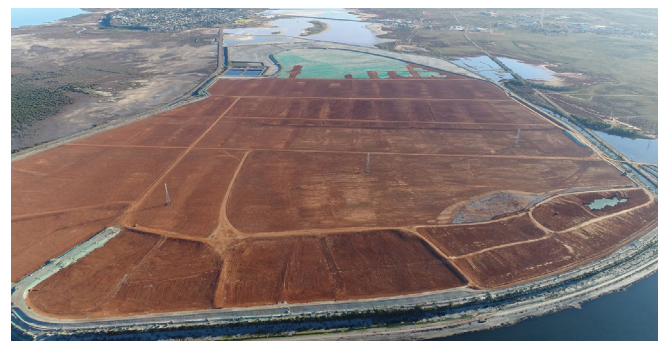
The image below shows the dust suppressant (green) progressively being covered by the top soil (brown).

Wide connector paths, or 'fingers' – provide us with a solid base to access the area and push the topsoil across the site. Specialized low ground-pressure earthmoving equipment has been utilised for the project, including a Pistenbully (a converted snow-plough machine). On average 2.5 hectares of topsoil is spread across the site per working day. The 'fingers' are also an important part of the stormwater management strategy - by providing a 500mm berm on completion they will retain stormwater within defined cells, which will encourage plant growth.

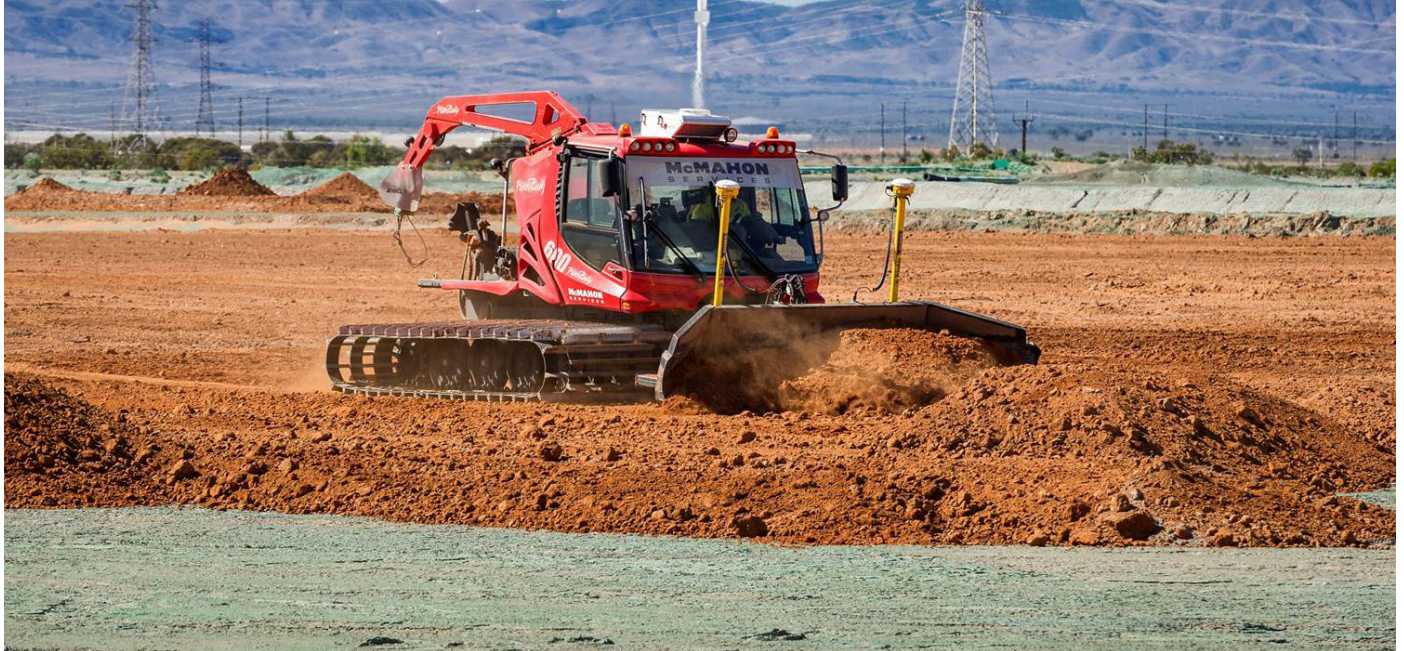
The objective of the rehabilitation strategy is to develop a safe, stable, self-sustaining landform. We expect 80% of the ash storage area will be spread with soil by late 2017 – this is almost 450,000 cubic metres. To date, approximately 160ha has been covered, which includes the southern end of the ash storage area which has historically been the location of dust lift-off. Wet conditions at the northern end of the site, which hinder access with heavy machinery, will mean the remaining 43 hectares is likely to require further time to dry over the summer months and may require a different rehabilitation strategy if the area remains inaccessible.

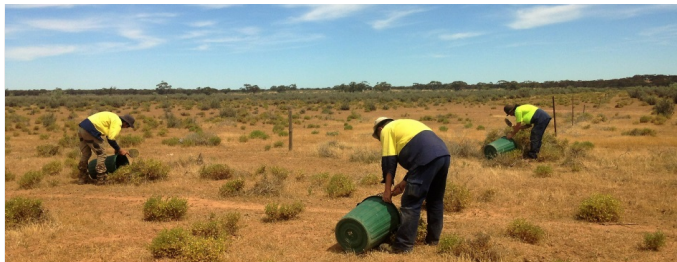
Over six tonnes of seed will be used to revegetate this area - resulting in a positive environmental outcome for Port Augusta. The image above shows the intensive process of collecting 6 tonnes of seed by hand.
